Manhole Inspection Summary

Manhole # S43I__044MH

Insp Date: **4/30/08 9:15 AM**

Location Address: **1618 s bethel st**

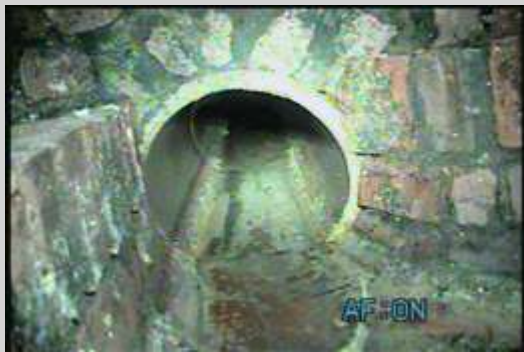
12 O'Clock Outflow

8 in. Circular Gravity Sewer
Pipe Out @ 12 O'Clock

Pipe Material: **Clay** ☐ Pipe Lined

Invert Depth: **9.16** (ft.) Flow Characteristics: **Fast**

Deposits: ☒ None ☐ Mud ☐ Sludge ☐ Debris ☐ Grease

Infiltration: **None** Pipe Seal Cond: **Unknown**

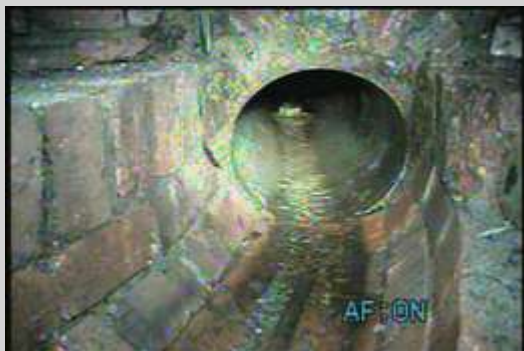
3 O'Clock Inflow

8 in. Circular Gravity Sewer
Pipe In @ 3 O'Clock

Pipe Material: **Clay** ☐ Pipe Lined

Invert Depth: **8.92** (ft.) Flow Characteristics: **Fast**

Deposits: ☒ None ☐ Mud ☐ Sludge ☐ Debris ☐ Grease

Infiltration: **None** Pipe Seal Cond: **Unknown**

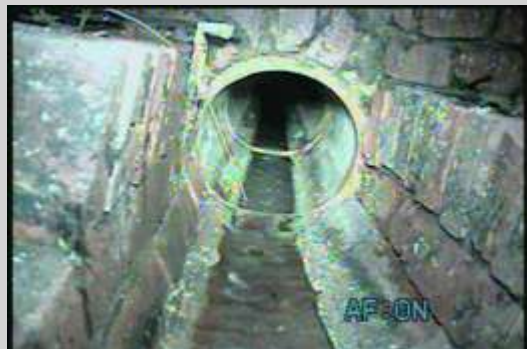
6 O'Clock Inflow

8 in. Circular Gravity Sewer
Pipe In @ 6 O'Clock

Pipe Material: **Clay** ☐ Pipe Lined

Infiltration: **None** Pipe Seal Cond: **Unknown**
